# USE OF ACOUSTIC EMISSION TO DISCRIMINATE DAMAGE MODES IN CARBON FIBRE REINFORCED EPOXY LAMINATE DURING TENSILE AND BUCKLING LOADING

P. Nimdum\*, J. Renard

*Centre des matériaux P. M. Fourt, Mines-Paris Tech, CNRS UMR 7633, BP 87, F-91003 Evry cedex  
\*pongsak.nimdum@mines-paristech.fr*

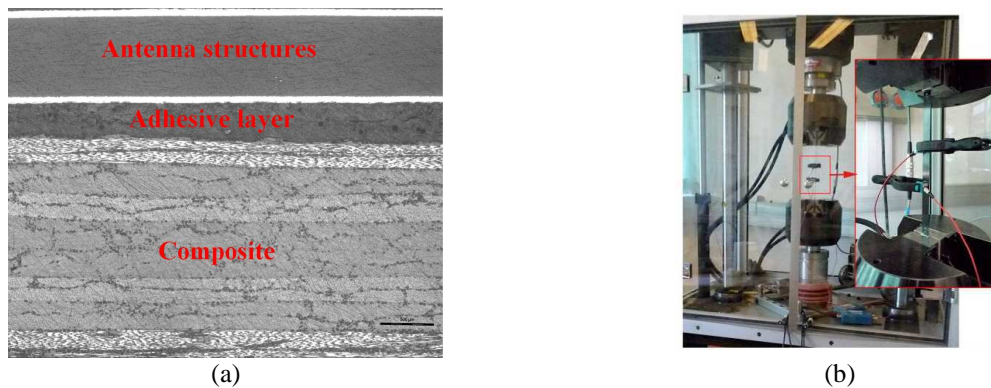
**Figure 1.** (a) Composite-antenna-structures and (b) experimental setup in tensile loading

In this study, two types of material have been investigated: composite material, composite-antenna-structure. First, the composite material was carried out on carbon (T700)/epoxy (M21). The density of carbon fibre is 1.8 g/cm<sup>3</sup> and that of the epoxy resin is 1.2 g/cm<sup>3</sup>. The volume fraction of carbon fibre was 58%. All of the specimens in tensile test of  $(0^\circ_8)$ ,  $(90^\circ_8)$ ,  $(45^\circ_8)$ ,  $(0^\circ_2, \pm 90^\circ_2)_S$ ,  $(90^\circ_2, 0^\circ_2)_S$ ,  $(0^\circ_2, \pm 20^\circ_2)_S$ ,  $(90^\circ_2, \pm 45^\circ_2, 0^\circ_2)_S$  and  $(0^\circ_2, \pm 45^\circ_2, 90^\circ_2)_S$  laminated with 0.125 mm for one ply thickness were 20x250 mm<sup>2</sup>. Each of these types is expected to generate preferentially certain damage modes during applied loading: fibre breakage, debonding between fibre and matrix, matrix cracking, delamination. All of the specimens were cut from plates (300x300 mm<sup>2</sup>) using a diamond wheel saw. The specimens were used aluminium tab in order to reduce the signal from the gripe during loading. In the same manner as tensile test, the similar dimension of  $(0^\circ_2, \pm 45^\circ_2, 90^\circ_2)_S$  laminate without aluminium tab was perform in buckling test. A second material was the composite-antenna-structure. This material compose of  $(0^\circ_2, \pm 45^\circ_2, 90^\circ_2)_S$  laminated and antenna system (metamaterial) (Fig. 1(a)). The similar dimension as the tensile test was studied to subject to buckling loading.

First, the composite tensile tests were performed at room temperature using hydraulic machine with low crosshead speed (0.2 mm/min) in order to avoid the saturation of EA system. Step loading was performed by using CDD camera and two sensors Micro-80 of AE with 60 mm distance in order to monitor progressive damages accumulation (Figure 1(b)). A continuous loading was also performed to investigate the loading effect condition. Before each test, the edges of specimens were polished.

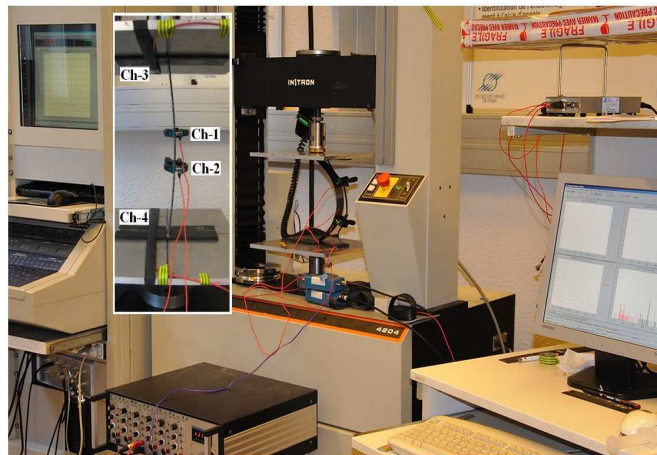
Figure 2. Experimental setup in buckling loading

In case of bending loading case, buckling tests were performed in order to avoid parasite signals due to contact load point during three or four point bending flexural test. When specimen is subjected to longitudinal forced, it will suddenly shift to one side and buckle before attaining the admissible compressive strain (Figure 2). Besides, the rubber plate was mounted on metal plate to reduce the parasite noise due to contact load point. In the similar manner with bending loading, the buckling test occur one side of specimen in tensile and another side in compression. Buckling test in composite and composite-antenna-structures specimens were performed with cross-head speed 1 mm/min with four sensors of Micro-80. Two sensors (Ch-3 and Ch-4) mounted on rubber material nearly the end of specimen were used to detect signal due to the friction between the specimen and rubber material. While two sensors (Ch-1 and Ch2) were used to detect the AE events of damage developed.

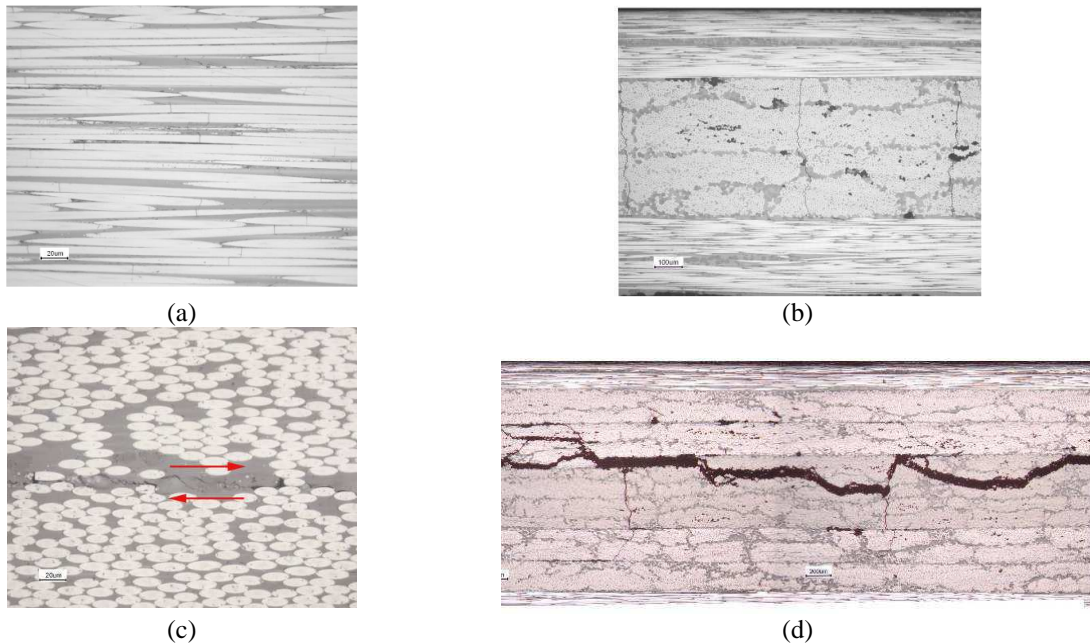
**Figure 3.** Damages observed under tensile test: (a) fibre breakage in  $(0_8)$  laminate, (b) ply cracking in  $(0_2, 90_2)_s$  laminate, (c) delamination in  $(0_2, \pm 20_2)_s$  laminate and (d) damages developed in  $(0_2, \pm 45_2, 90_2)_s$  laminate

By previous study [9] showed that the mechanical behaviour of composite material obtained by tensile loading showed quasi-linear up to failure. This reason is quite difficult to understand damage mechanism when we consider only stress-strain relation. Consequently, AE response during tensile loading were analysed and we found that a good agreement between damage evolution obtained by experimental observation and AE hits accumulated on  $(0_8)$ ,  $(90_8)$ ,  $(45_8)$ ,  $(0_2, 90_2)_S$ ,  $(90_2, 0_2)_S$ ,  $(0_2, \pm 45_2, 90_2)_S$  and  $(90_2, \pm 45_2, 0_2)_S$  laminates. Matrix cracking, fibre breakage, fibre/matrix debonding and delamination can be found (Figure 3). The fibre breakage and the delamination occurred primarily in  $(0_8)$  and  $(0_2, \pm 20_2)_S$  laminates, respectively. While,  $(0_2, 90_2)_S$  and  $(90_2, 0_2)_S$  laminates provoked the matrix cracking. Finally, all of the damages in above can be observed in  $(0_2, \pm 45_2, 90_2)_S$  and  $(90_2, \pm 45_2, 0_2)_S$  laminates. The more detail of damages and AE results in tensile loading of composite material were presented in ref. [9]. Concerning to buckling test, the similar damage can be found as the tensile test. We found that damage mechanisms were developed not only in tensile side but also in compression side (Figure 4). Moreover, other damages such as splitting also occurred during buckling loading.

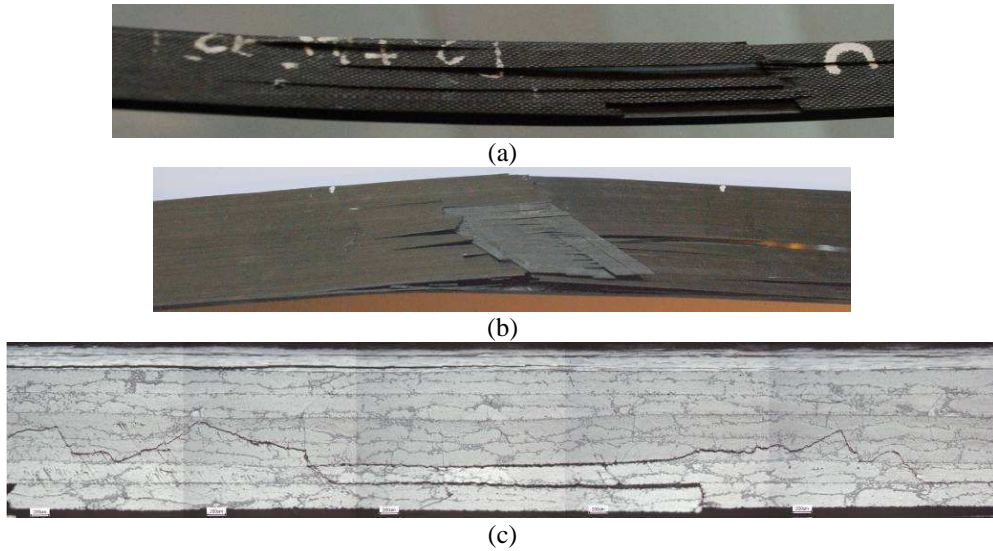
**Figure 4.** Damage mechanisms in buckling loading: (a) compression side and (b) tension side (c) damage in thickness direction

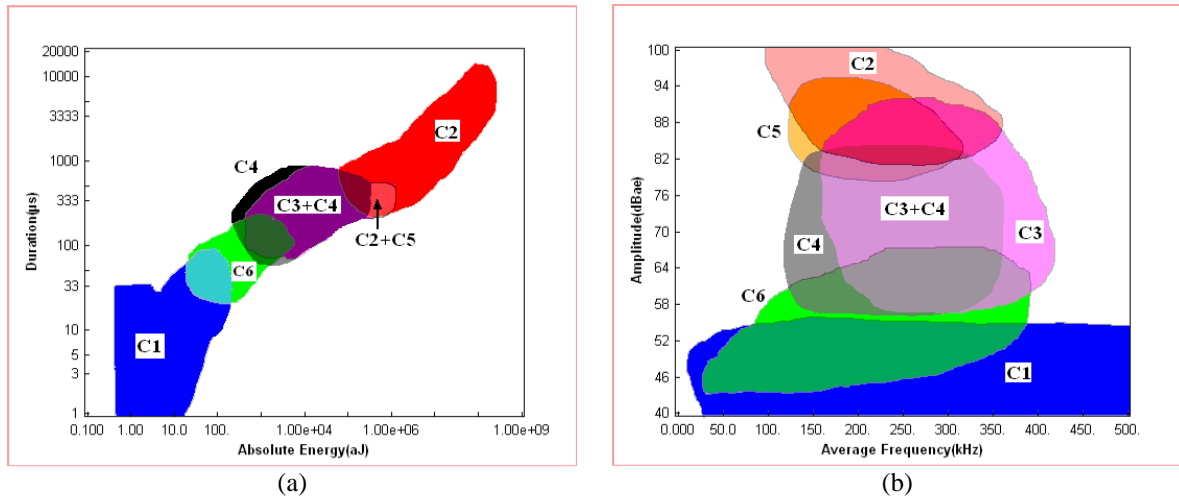
**Figure 5.** Classifications of damage in composite material by using tensile loading

Fig. 5 shows the classification of AE parameters for each damage in composite material: fibre breakage (C1), matrix macro-cracking (C2), matrix micro-cracking (C3), micro-delamination

or delaminate onset (C4), macro delamination and longitudinal matrix cracking (C5) and interfacial debonding (C6). Note that the splitting in buckling test represents between C2 and C5 class. We found that similar nature of AE signals of composite material can be found during tensile and buckling loading (Figure 6(a)). Also, most of them have the peak frequency which is higher than 300 kHz (Figure 7). We found that the fibre break showed low amplitude (<60dB), while ply cracking, macro delamination and splitting showed high amplitude (>80dB). The delamination onset and the fibre/matrix debonding showed intermediate amplitude. Note that AE signals with high amplitude also represented high peak power.

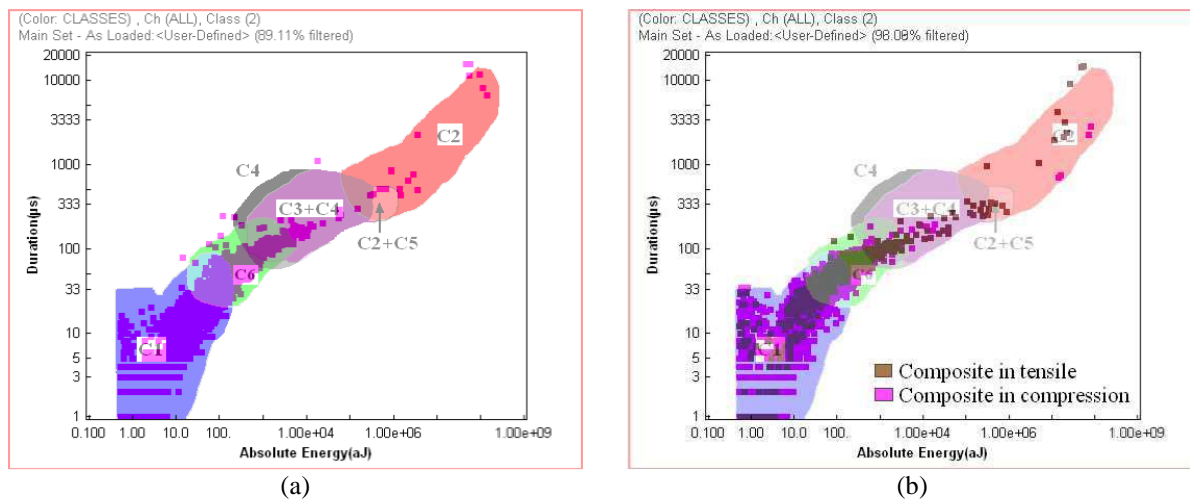
**Figure 6.** AE signal response of buckling test of composite material (a) and buckling test in composite-antenna-system under tensile in composite side (b) to comparison with tensile loading

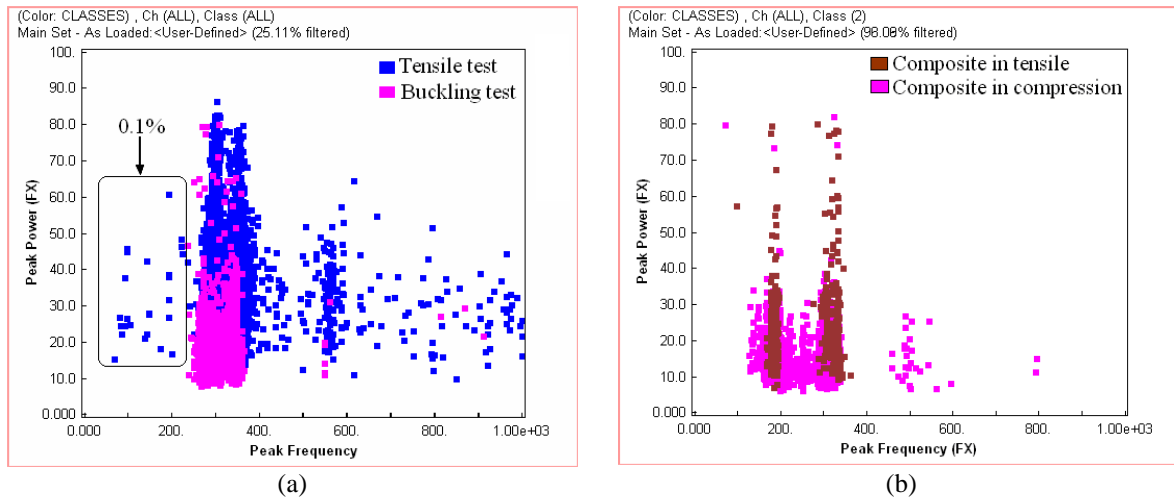
**Figure 7.** Peak frequency under tensile and buckling loading in composite case (a) and buckling loading in composite-antenna-system (b)

The multivariable method is available to discriminate on each damage in composite material both tensile test and buckling test. Finally, the validation of AE clustering has been carried out on composite antenna specimen under buckling loading. The fibre breakage represented low amplitude, absolute energy and duration while the matrix cracking, the macro delamination and the splitting showed high amplitude, absolute energy and duration. Damage modes of AE clustering showed a good correlation with experimental results. In addition, low peak frequency was found in buckling test of composite-antenna-systems. We suppose that this low peak frequency is corresponding to adhesive debonding of composite and antenna systems..

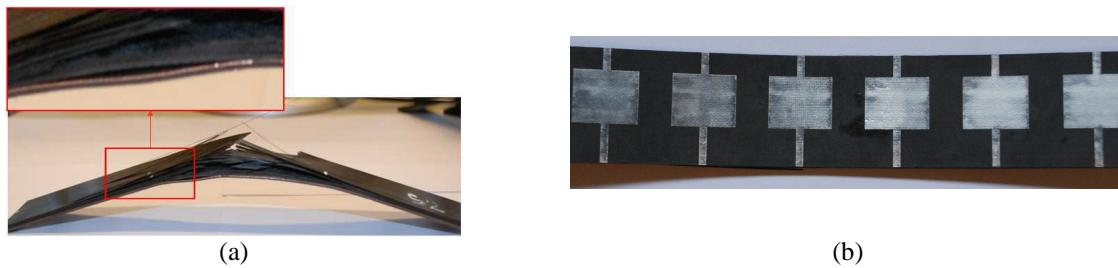
**Figure 8.** Damages developed of composite-antenna-structures under buckling loading: (a) debonding occurred in tensile side and (b) no damage occur in compression side

In composite-antenna-structure specimen subjected in buckling test, only composite side (in tensile or compression) can be observed the damage developed (Figure 8). These damages are similar with the composite specimen. Furthermore, composite/antenna systems debonding also occurred in both case (see in Figure 8 for composite in tensile). Although AE response of absolute energy as a function of duration in composite-antenna-systems is similar with composite material under tensile and buckling loading (Figure 6(b)), but peak frequency is different. In present of antenna systems joined by adhesive layer provoked the low peak frequency (<300 kHz). We found that 25% and 50% of AE events represent in low peak frequency in tensile and compression side, respectively. Due to high attenuation in polymer material; consequently, no signal can not be detect during damage occurred in polymer. In this reason, we suppose that the low peak frequency signal provide from the debonding between composite and antenna systems. However, this hypothesis is able to verify in adhesive joint test by using special fixture so called Arcan-Mines fixture. Beside, in case of composite in tensile side, more detected signals can obtain to compare with another one. This phenomenon is corresponding to damage developed which many damage occurred when the composite specimen subjected in tensile side. While, the splitting associated with cluster of fibre break were primary in case of composite in compression side.
